DEPARTMENT OF TRANSPORTATION**DIVISION OF ENGINEERING SERVICES**

Contract #: 04-0120F4Cty: SF/ALA Rte: 80 PM: 13.2/13.9File #: 1x.28**WELDING INSPECTION REPORT****Resident Engineer:**Pursell, Gary**Address:** 333 Burma Road**City:** Oakland, CA 94607**Report No:** WIR-014310**Date Inspected:** 20-May-2010**Project Name:** SAS Superstructure**OSM Arrival Time:** 1000**Prime Contractor:** American Bridge/Fluor Enterprises, a JV**OSM Departure Time:** 1830**Contractor:** American Bridge/Fluor Enterprises, a JV**Location:** Job Site

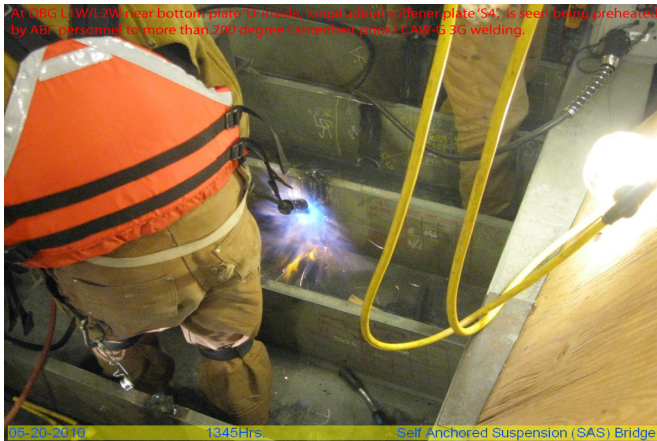
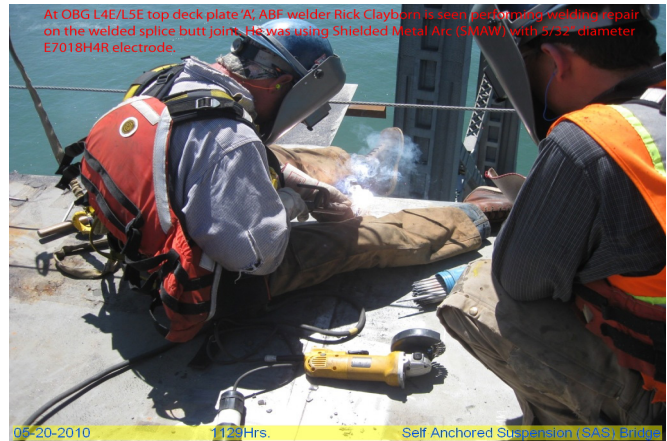
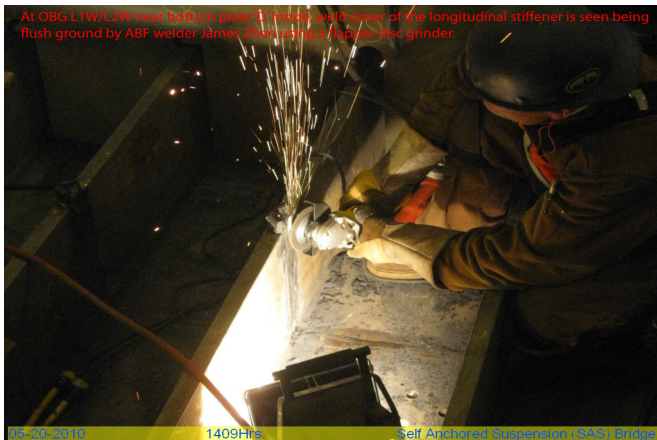
At OBG L4E/L5E top deck plate 'A' outside, QA randomly observed ABF/JV qualified welder Rick Clayborn ID # 2773 perform CJP groove welding repair. The welder was observed welding in the 1G (flat) position utilizing Shielded metal Arc Welding (SMAW) with 5/32" diameter E7018H4R electrode implementing welding procedure ABF-WPS-D15-1000-Repairs. The repair excavations were preheated to more than 140 degree Fahrenheit using propane gas torch prior welding. During the shift, ABF QC Tom Pasqualone was noted monitoring the welder. Prior welding, ABF QC Tom Pasqualone was also observed performing Magnetic Particle Testing (MT) using Parker Contour Probe with red magnetic powder as detecting media on the repair excavation. During the shift, the welder has completed six welding repairs and that should complete all the welding repairs in this plate.

At OBG L4E/L5E top deck plate 'A' outside, this QA performed a 10% Magnetic Particle Testing (MT) using a Parker Contour Probe electromagnetic yoke with corresponding red magnetic powder as detecting media to the welded splice butt joint. The surface profiles of the joints were as welded and cleaned with wire brush. There were no significant defects noted during the test.

At OBG L1W/L2W plate 'D' inside, ABF Chun Fai Tsui ID # 3426 was noted welding manually at the splice butt joint of the longitudinal stiffener S2, S3 and S4 (320mm long X 35mm thickness). QA randomly observed the welder perform Complete Joint Penetration (CJP) welding cover pass. The welder was noted welding in the

vertical (3G) position utilizing an semi-automatic dual shield Flux Cored Arc Welding (FCAW-G) with E71T-1M, 1/16" diameter wire electrode and implementing Caltrans approved Welding Procedure Specification (WPS) ABF-WPS-D15-3110-3. The joint being welded has a double V-groove butt joint and was battered (with temporary backing bar in place) due to excessive gap. The backing bar has been removed and the surfaced was ground smooth prior welding. The splice joint was preheated and maintained to greater than 200 degree Fahrenheit using propane gas torch prior welding. During welding, ABF Quality Control (QC) Bonifacio Daquinag was noted monitoring the welder and parameters of the welder. QA performed parameter readings during welding with the following results; 200 amperes, 22.2 volts. Welding parameters noted are deemed acceptable to contract specifications. While Welder Chun Fai Tsui on the cover of the stiffener splice butt joints, welder James Zhen was also flush grinding the weld cover of the splice butt joint.
